INSPECTION REPORT: KENSINGTON GOLD MINE

Date of Inspection: Wednesday December 18, 2019
Date of Report: Monday January 6, 2020
USDA Forest Service Inspector: Richard Dudek

This inspection included the Access roads, Comet Development Pile, Comet Water Treatment Plant (CTWP), Sherman Creek Outfall 001, mill bench, Pit 4, the TTF area, the cold storage facility, and the fuel depot.

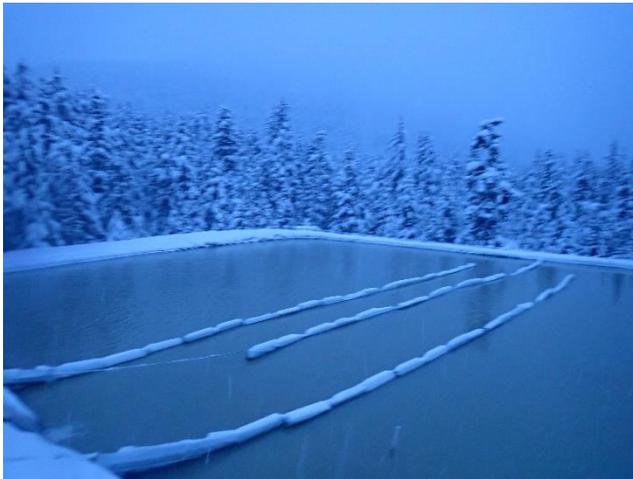
On 12/18/2019, the CWTP was treating 1,675 gallons per minute (gpm). Pond 1 was receiving mine site water (Photo 1). Pond 2 was receiving back wash from the water treatment plant (Photo 2).

Photo 1. Comet water treatment plant's Pond 1.

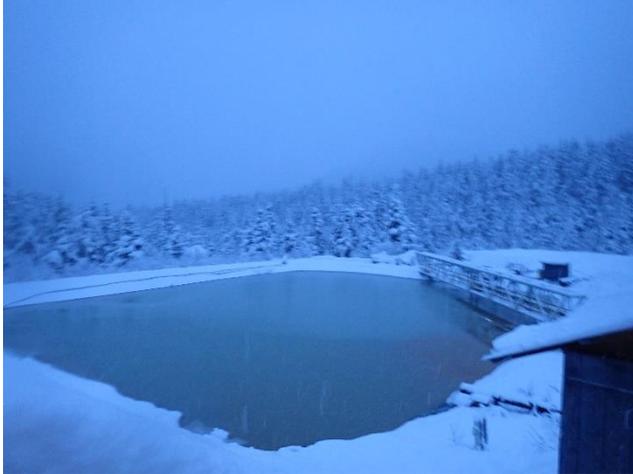
Photo 2. The Comet water treatment plant's Pond 2.

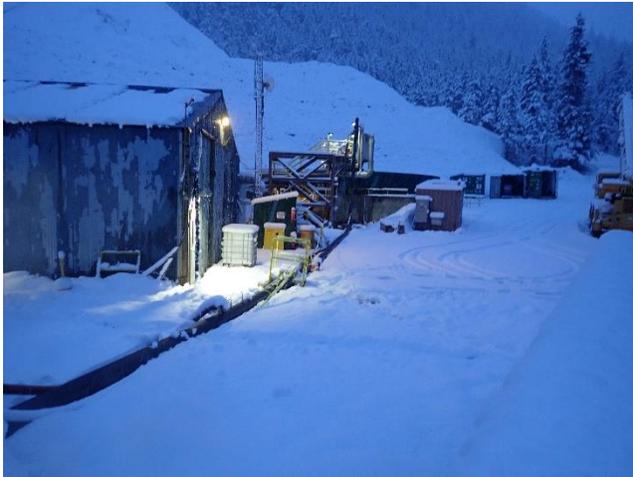
CWTP personnel recently installed a new waterline from the pump house for treatment plant #1 to the clarifier (Photo 3).

Photo 3. The new waterline installed from the clarifier to the pump house for treatment plant #1

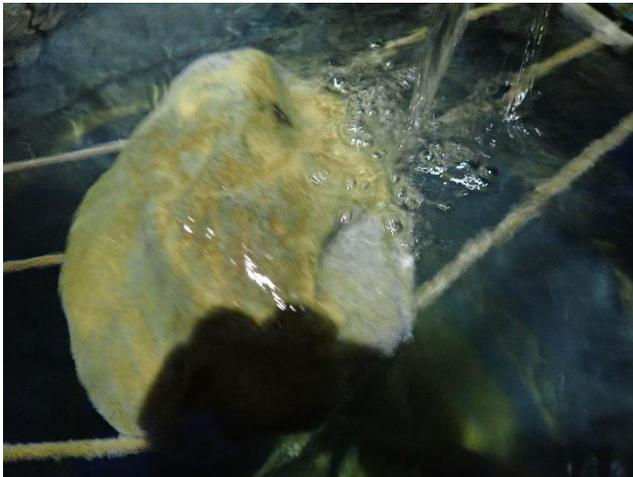
White material was observed on the clean test rock used for monitoring its accumulation (Photo 4). Personnel at the CWTP continue to use calcium chloride (CaCl_2) to help remove white material out of solution.

Photo 1. The CWTP's test/observation rock for white material accumulation.

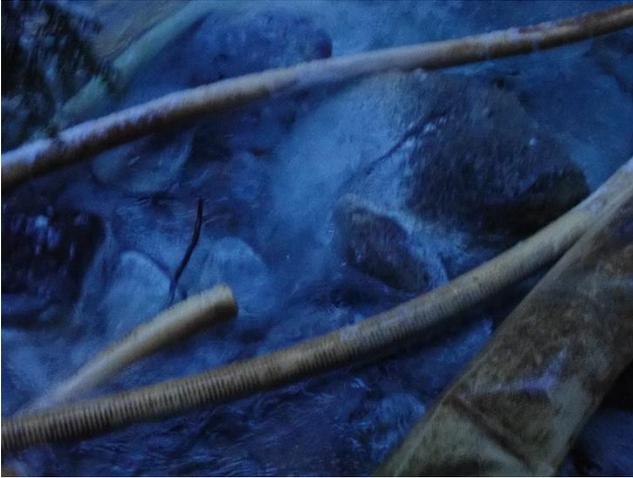
White material was observed on the rocks in the creek bed (Photo 5).

Photo 2. White material observed in the creek (outfall 001).

Inspect for white material in Sherman Creek.

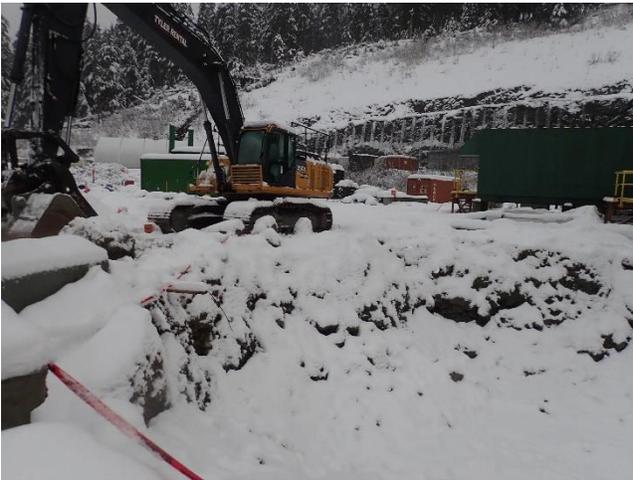
Coeur personnel is almost completed with the removal of the diesel contaminated soils from where the decommissioned generators were located (Photo 6).

Photo 3. Recent snow covering the location of the old generators where the diesel contaminated soils were removed.

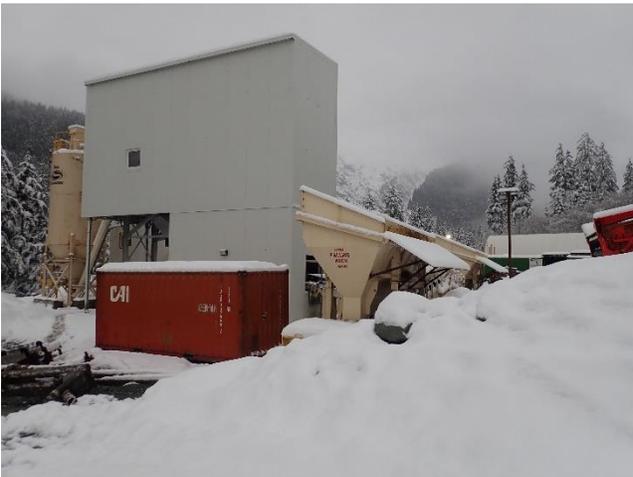
Photo 4. Pug plant at pit 4.

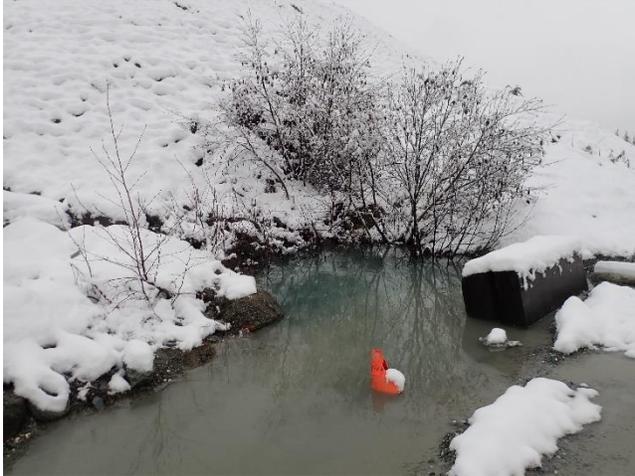
The pug plant is currently offline for the winter months (Photo 7). A drain (Photo 8) for Pit 4's settling pond that is located next to the road for the x-ray sorter is clogged and will eventually need to be cleaned out.

Photo 5. A clogged drain for pit 4's settling pond.

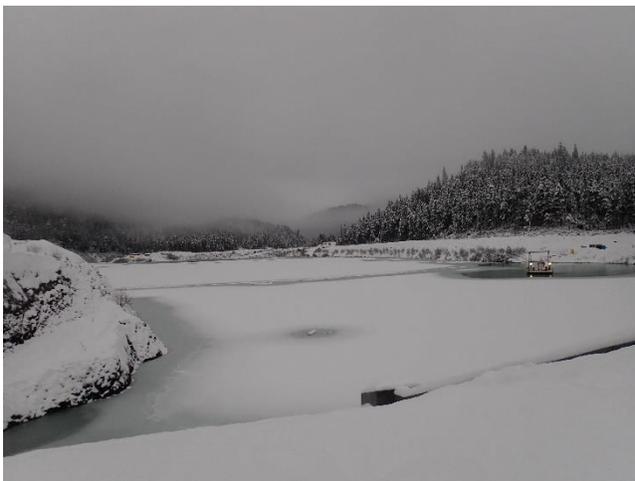
The TTF is mostly frozen over and covered in snow. The TTF's recorded water level on 12/18/2019 was 710.65 feet (Photos 9-10).

Photo 6. The TTF.

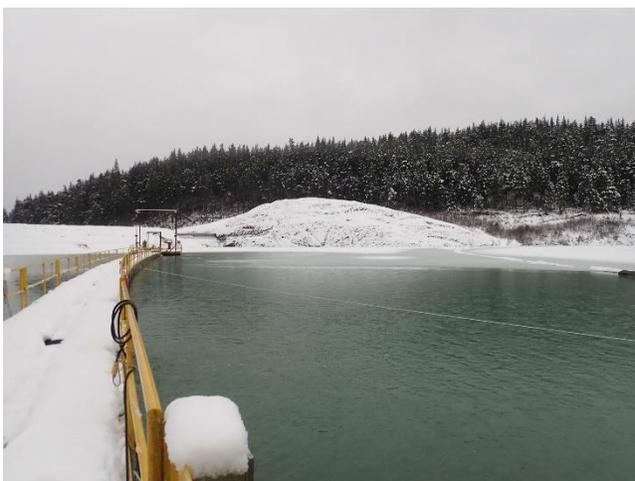
Photo 10. The reclaim barge for the TTF recycles water (200-gpm) from the TTF to the mill. This is also the location where the TTF's daily water level is recorded.

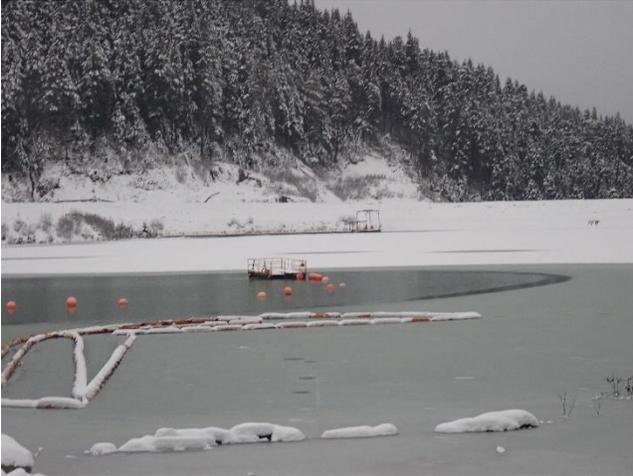
After the most recent bathymetry survey, the tailings barge was moved to the north section of the TTF (Photo 11) to facilitate filling in deeper sections within that part of the facility.

Photo 11. The TTF's tailings placement barge.

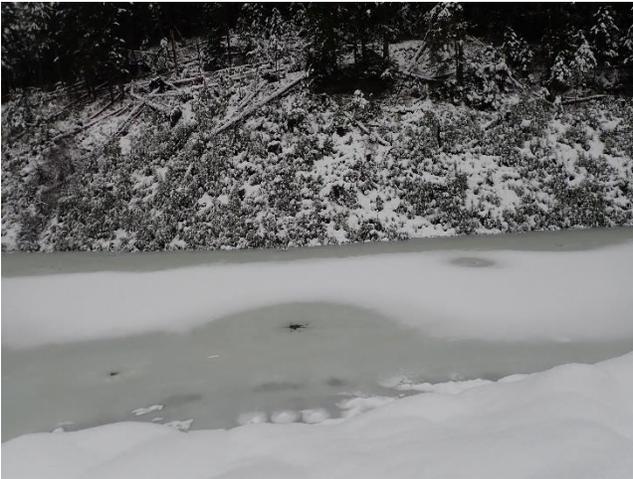
There northern TTF, and the laydown area were covered in snow and ice (Photo 12).

Photo 12. The northern TTF area.

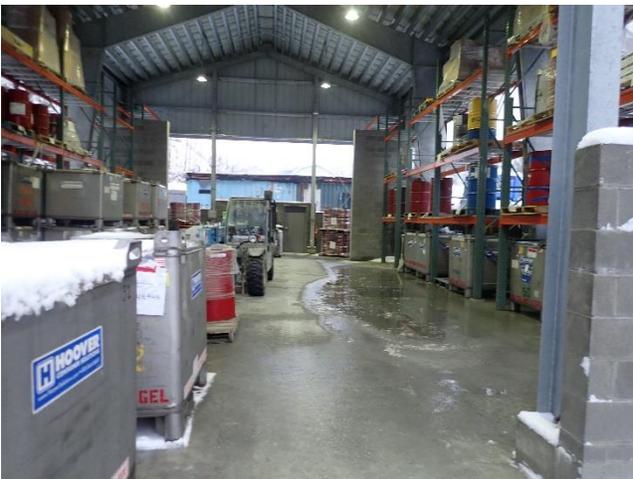
The facility was tidy and in order (Photo 13).

Photo 13. Cold storage facility.

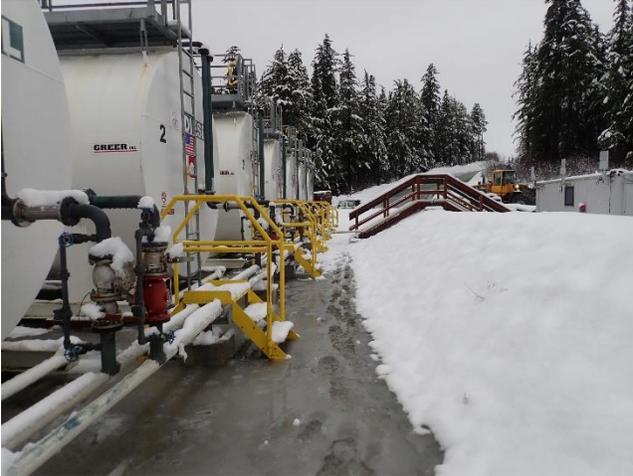
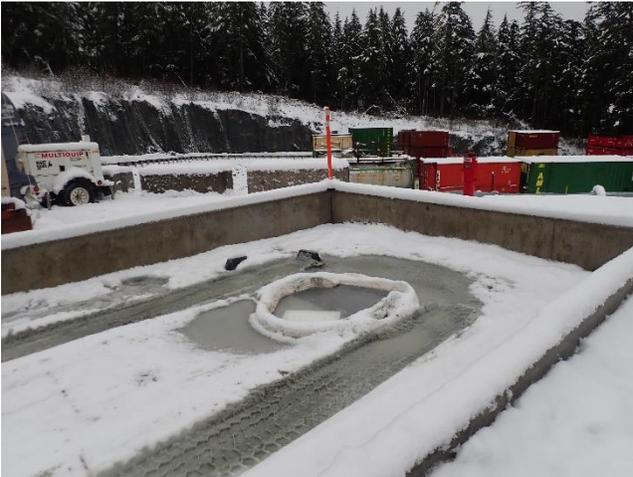
There were no observed fuel leaks, sheening, and/or spills at the facility (Photos 14-15).

Photo 14. The fuel depot.

Photo 15. The fuel depot's refueling pad.
